# Manhole Inspection Summary

Manhole # S09QQ1022MH

Insp Date: **7/23/08 10:18 AM**

**Location** Address: **3031 SPAULDING AVE**

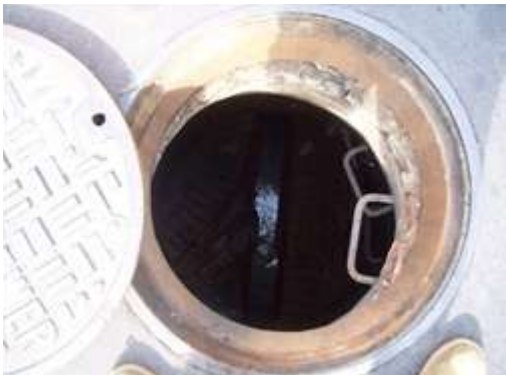
Defect 1

Offset: **2** (in.)

FRAME OFFSET

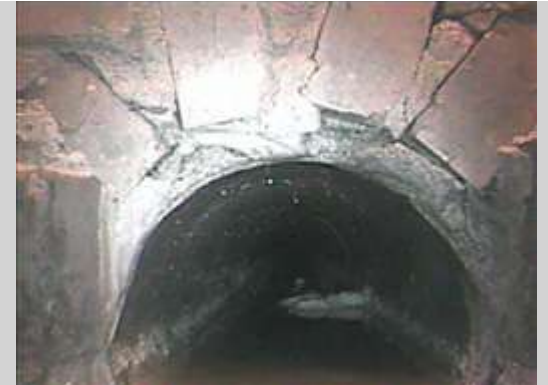
12 O'Clock Outflow

8 in. Circular Gravity Sewer  
Pipe Out @ 12 O'Clock

Pipe Height: (in.) Direct  
Pipe Material: **Clay** ☐ Pipe Lined  
Invert Depth: **7.98** (ft.) Flow Characteristics: **Slow**  
Deposits: ☐ None ☐ Mud ☐ Sludge ☒ **Debris** ☐ Grease  
Silt Depth: **0.5** (in.) Deposits Extent: **Light**  
Infiltration: **None** Pipe Seal Cond: **Sound**

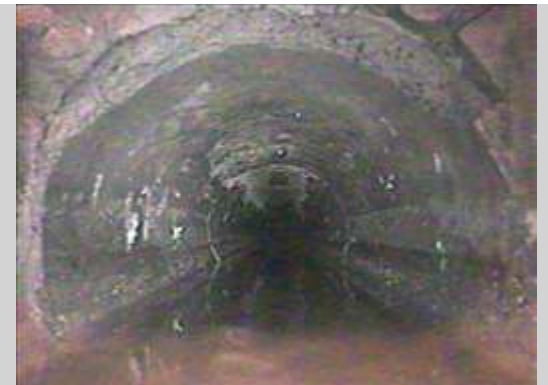
6 O'Clock Inflow

8 in. Circular Gravity Sewer  
Pipe In @ 6 O'Clock

Pipe Height: (in.) Direct  
Pipe Material: **Clay** ☐ Pipe Lined  
Invert Depth: **7.80** (ft.) Flow Characteristics: **Slow**  
Deposits: ☐ None ☐ Mud ☐ Sludge ☒ **Debris** ☐ Grease  
Silt Depth: **0.5** (in.) Deposits Extent: **Light**  
Infiltration: **None** Pipe Seal Cond: **Sound**

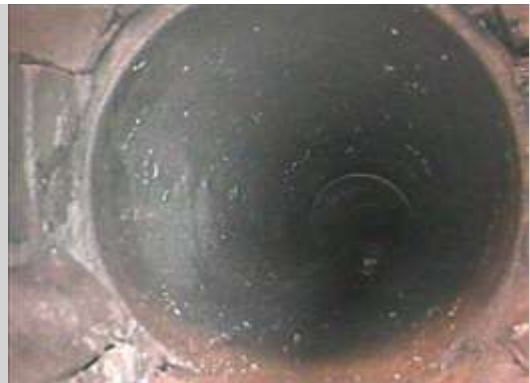
7 O'Clock Inflow

Pipe In @ 7 O'Clock

Invert Depth: **7.88** (ft.) Flow Characteristics: **None**

Deposits: ☒ None ☐ Mud ☐ Sludge ☐ Debris ☐ Grease

Infiltration: **None** Pipe Seal Cond: **Sound**
